# Owyhee Dairy Complaint Investigation Report

By Emily Montague

May 22, 2019

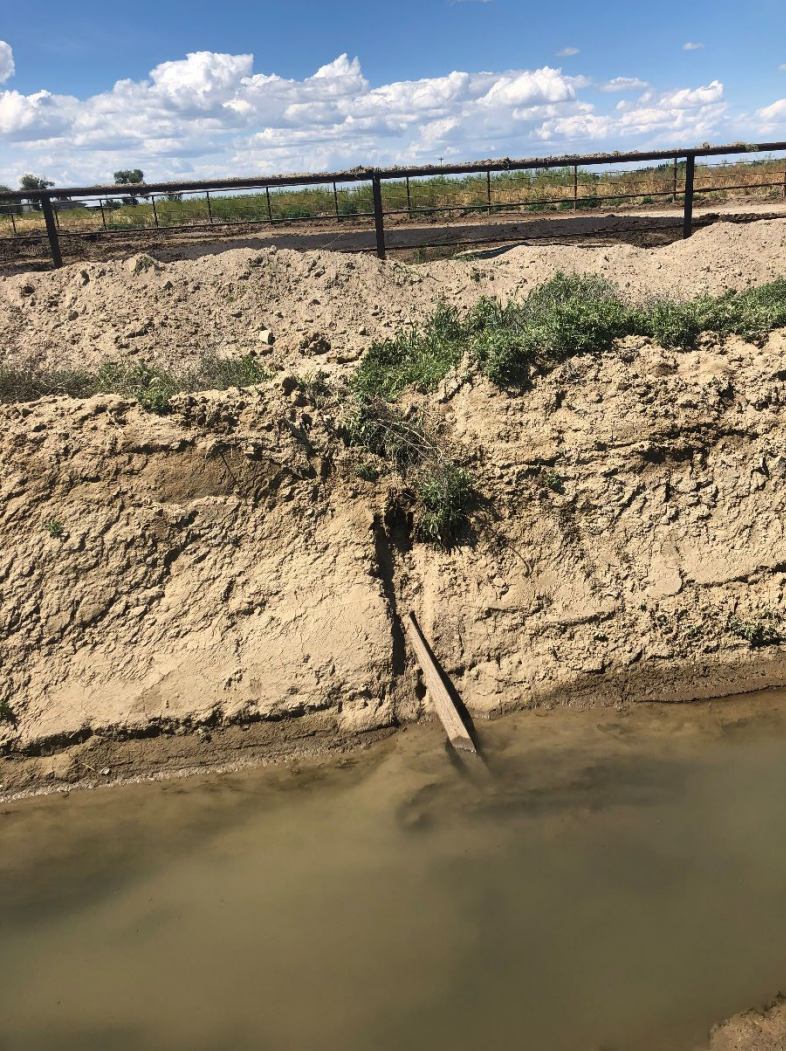
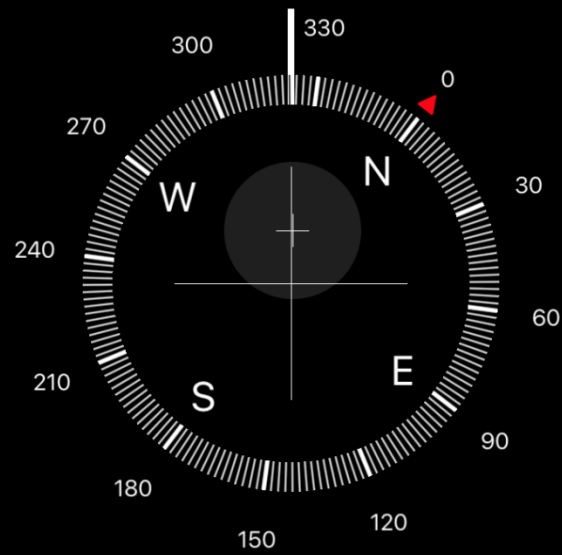
Photograph taken by Inspector Montague on May 23, 2019 facing 322 degrees Northwest shows two feet high berming added between the Southeast corrals and the ditch that borders the South and Southeast side of Owyhee Dairy. Berming still needs to be compacted to the required 300 PSI to protect potential runoff from the facility from entering the ditch. Photograph also shows where the main active discharge was observed on May 21, 2019 has since been stopped.

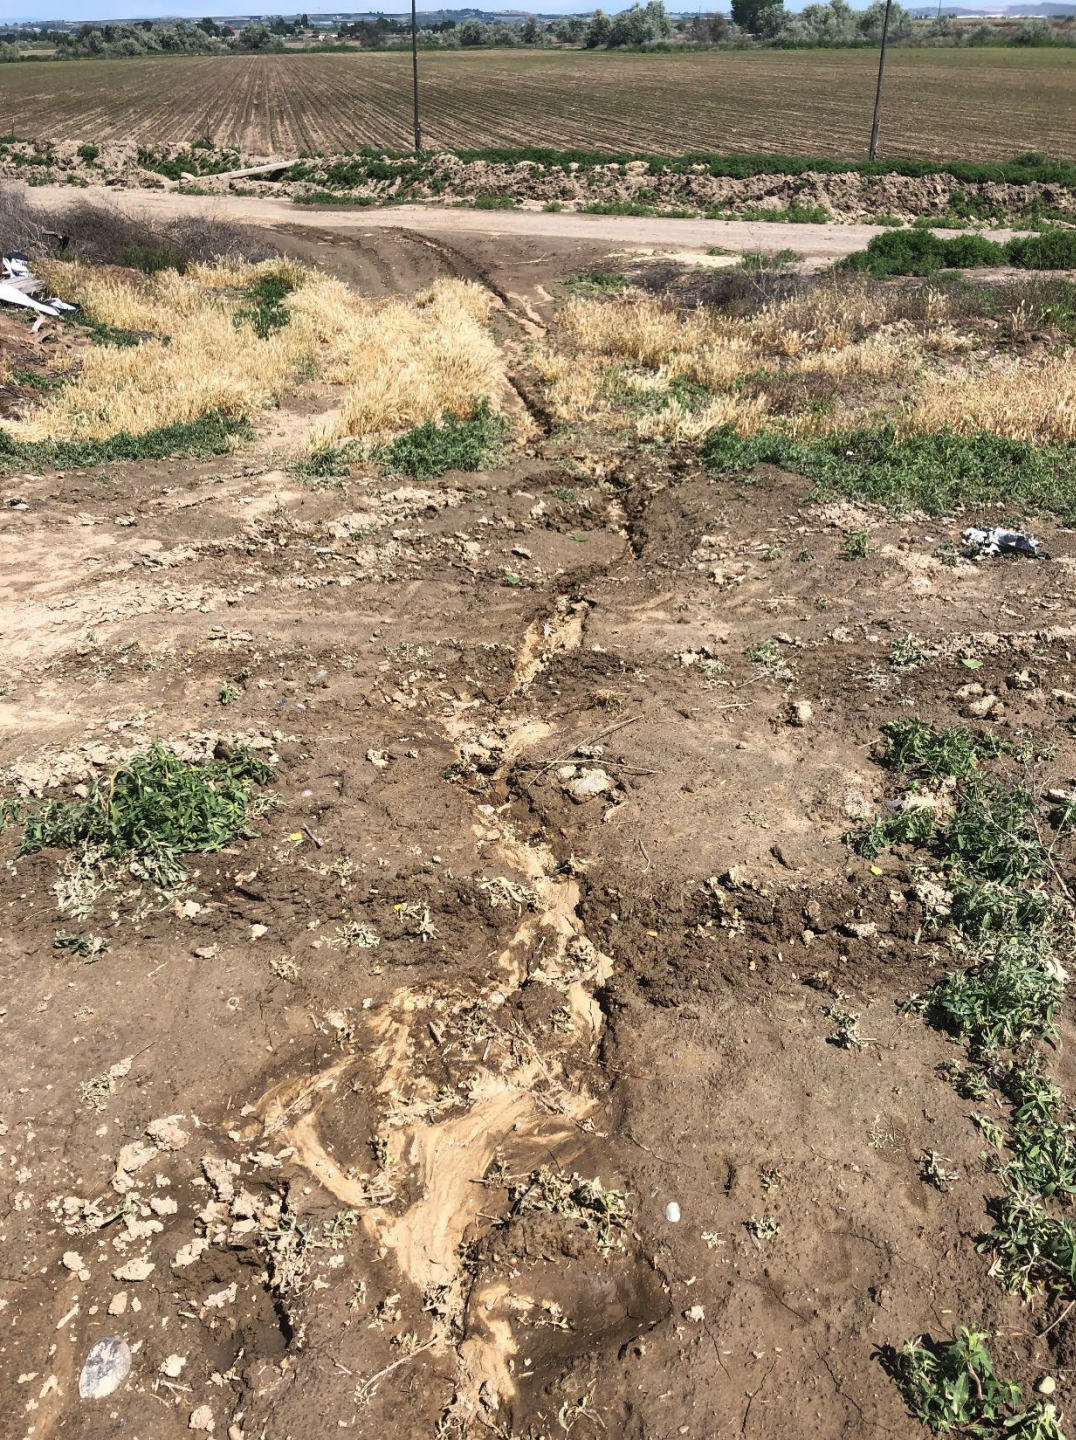
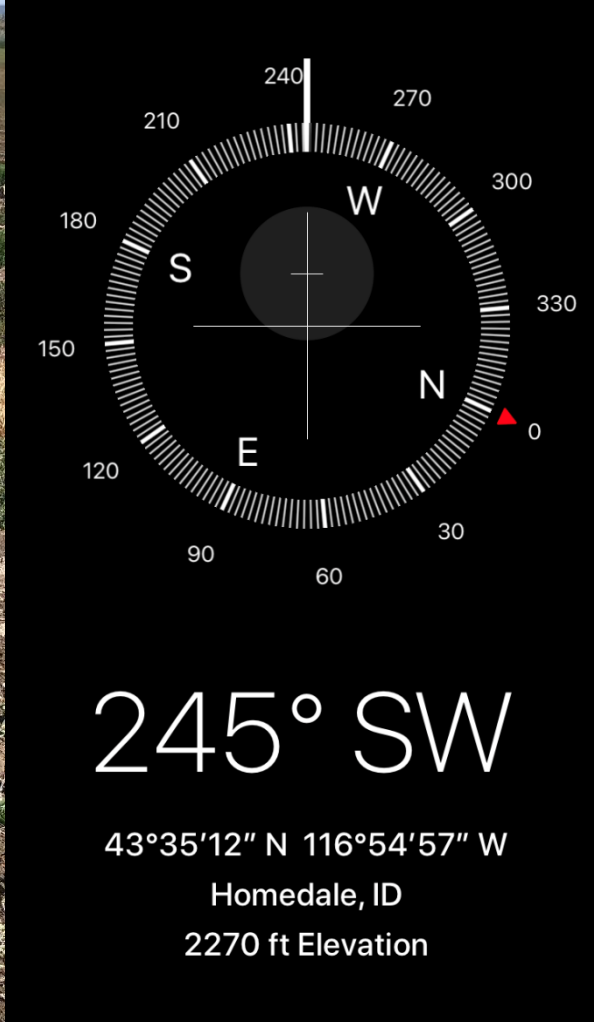
Photograph taken by Inspector Montague on May 23, 2019 facing 245 degrees Southwest shows where commodity storage discharge was observed on May 21, 2019 at Owyhee Dairy has since been stopped. Nutrient runoff, oil, and diesel fuel are no longer running down towards Town Ditch at the time of inspection on May 23, 2019.
